Confidential Inspection Report
19 Grant St
Spencer MA 01562

April 18, 2019

Inspection Contents

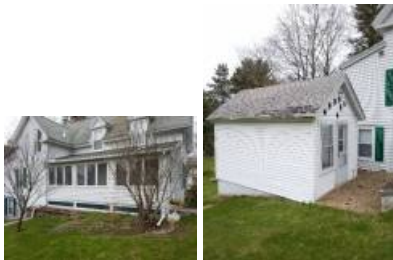
<i>Structure:</i>	<input type="checkbox"/>	<input type="checkbox"/>	<input checked="" type="checkbox"/>	Glossed porch wood frame minimal view below interior floor entry bouncy not able to view below restricted exterior and covered inside with carpet.
	<input checked="" type="checkbox"/>	<input type="checkbox"/>	<input type="checkbox"/>	Detached shed.

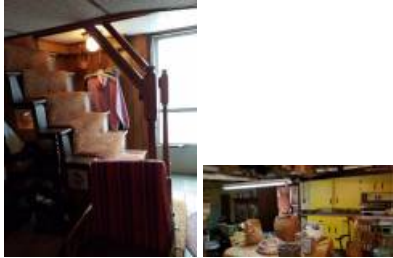
Access: Viewing was restricted by wall coverings, storage etc. Basement is partially finished.

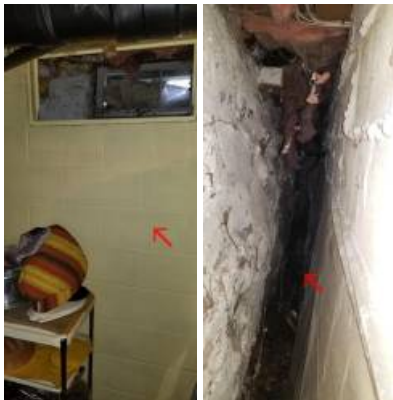
Walls: OK MM RR
 There is a block wall covering the original stone wall makes viewing restricted to evaluate,
